Manhole Inspection Summary

Manhole # S15GG_005MH

Location Address: **1642 BRADDISH AVE**

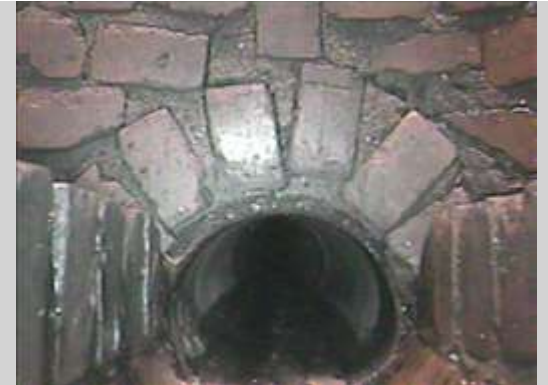
12 O'Clock Outflow

8 in. Circular Gravity Sewer
Pipe Out @ 12 O'Clock

Pipe Height: (in.) Direct
Pipe Material: **Clay** ☐ Pipe Lined
Invert Depth: **7.85** (ft.) Flow Characteristics: **Slow**
Deposits: ☒ None ☐ Mud ☐ Sludge ☐ Debris ☐ Grease
Silt Depth: (in.) Deposits Extent:
Infiltration: **None** Pipe Seal Cond: **Sound**

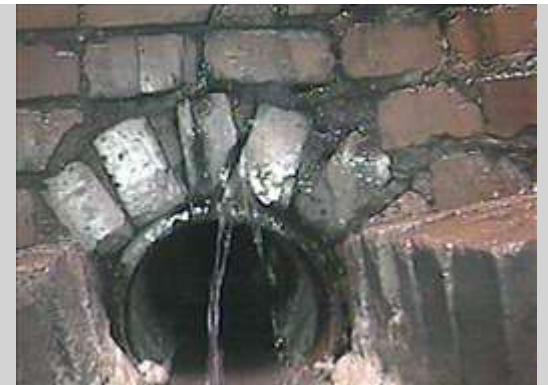
3 O'Clock Inflow

Comments **HEAVY INFILTRATION AROUND PIPE SEAL @ 3 O'CLOCK - SEE PHOTO**

8 in. Circular Gravity Sewer
Pipe In @ 3 O'Clock

Pipe Height: (in.) Direct
Pipe Material: **Clay** ☐ Pipe Lined
Invert Depth: **7.75** (ft.) Flow Characteristics: **Fast**
Deposits: ☒ None ☐ Mud ☐ Sludge ☐ Debris ☐ Grease
Silt Depth: (in.) Deposits Extent:
Infiltration: **Runner** Pipe Seal Cond: **Cracked**

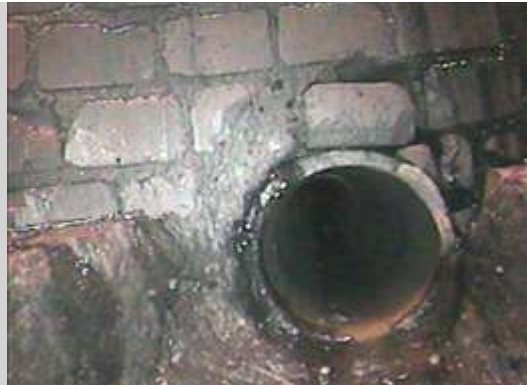
6 O'Clock Inflow

6 in. Circular Gravity Sewer

Pipe In @ 6 O'Clock

Infiltration: **Evidence** Pipe Seal Cond: **Cracked**
